NIST NCSTAR 1-5A

Federal Building and Fire Safety Investigation of the World Trade Center Disaster

Visual Evidence, Damage Estimates, And Timeline Analysis

(Chapter 9 - Appendix C)

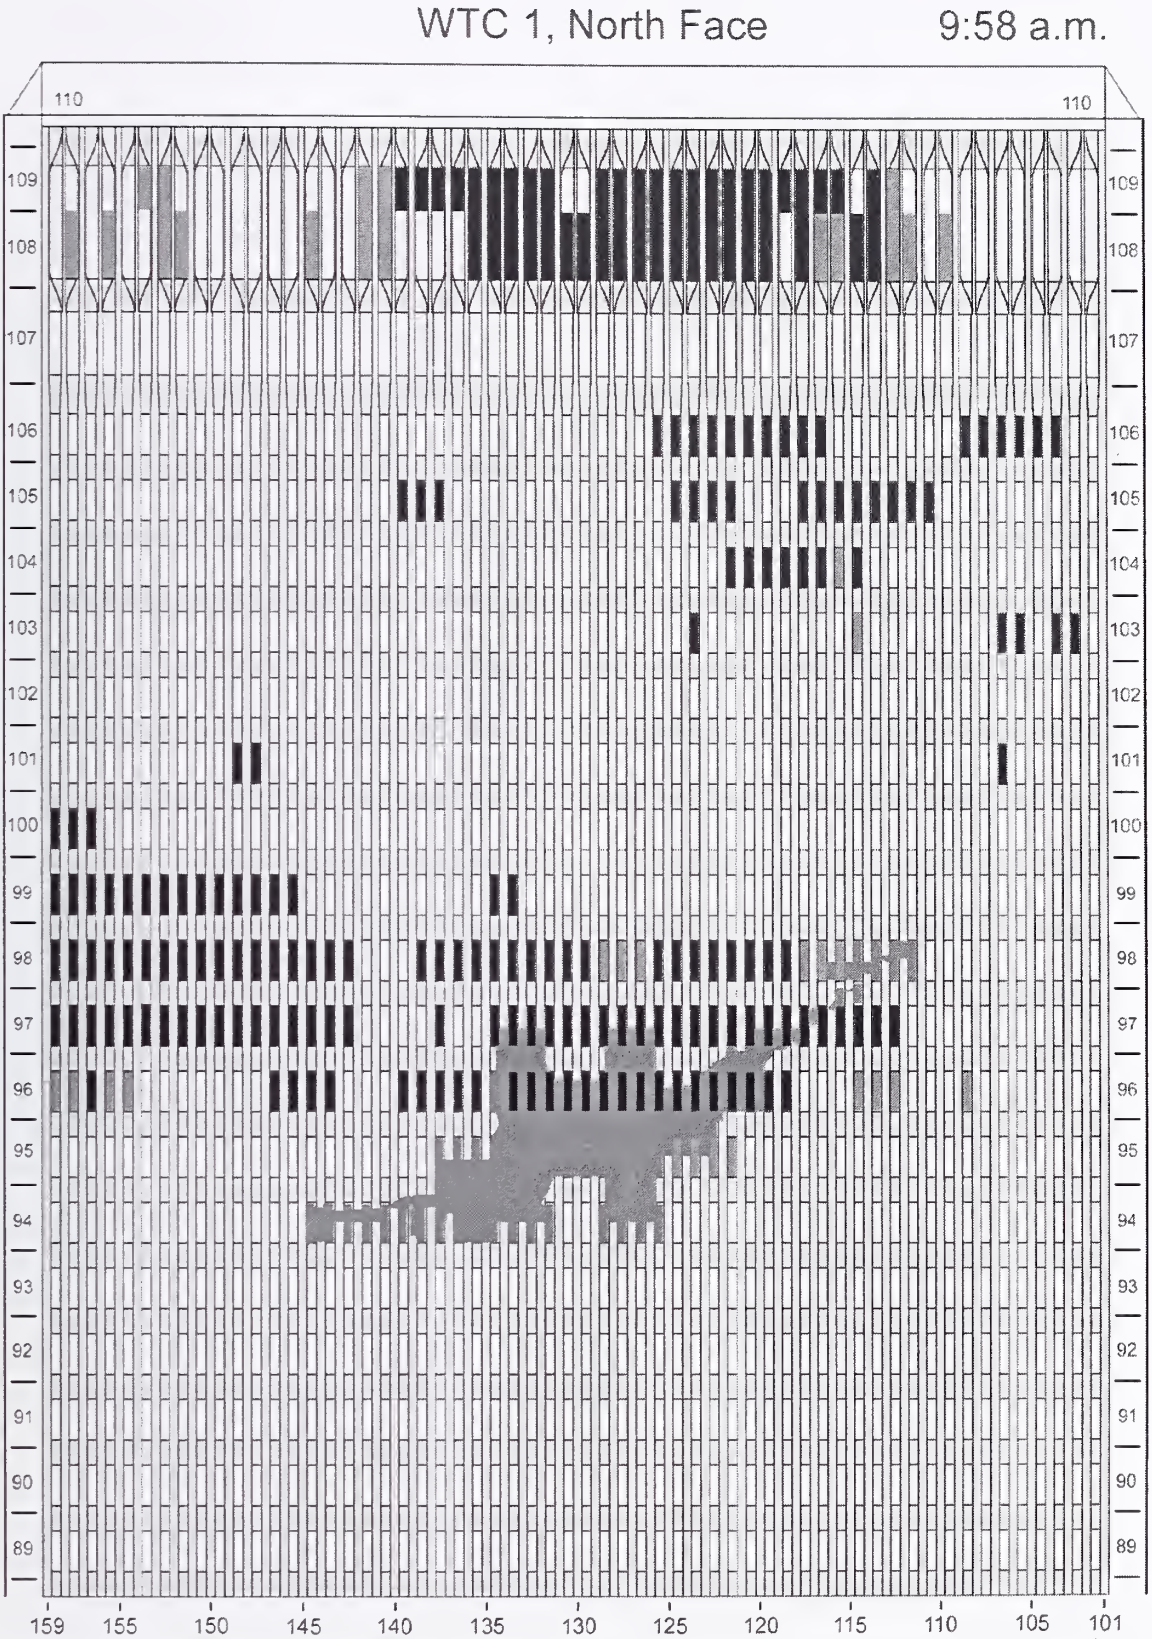
Figure C-44. Diagram of the north face of WTC 1 for floors 89 to 110 at 9:58 a.m. showing windows where smoke was observed and those that were hidden from view.

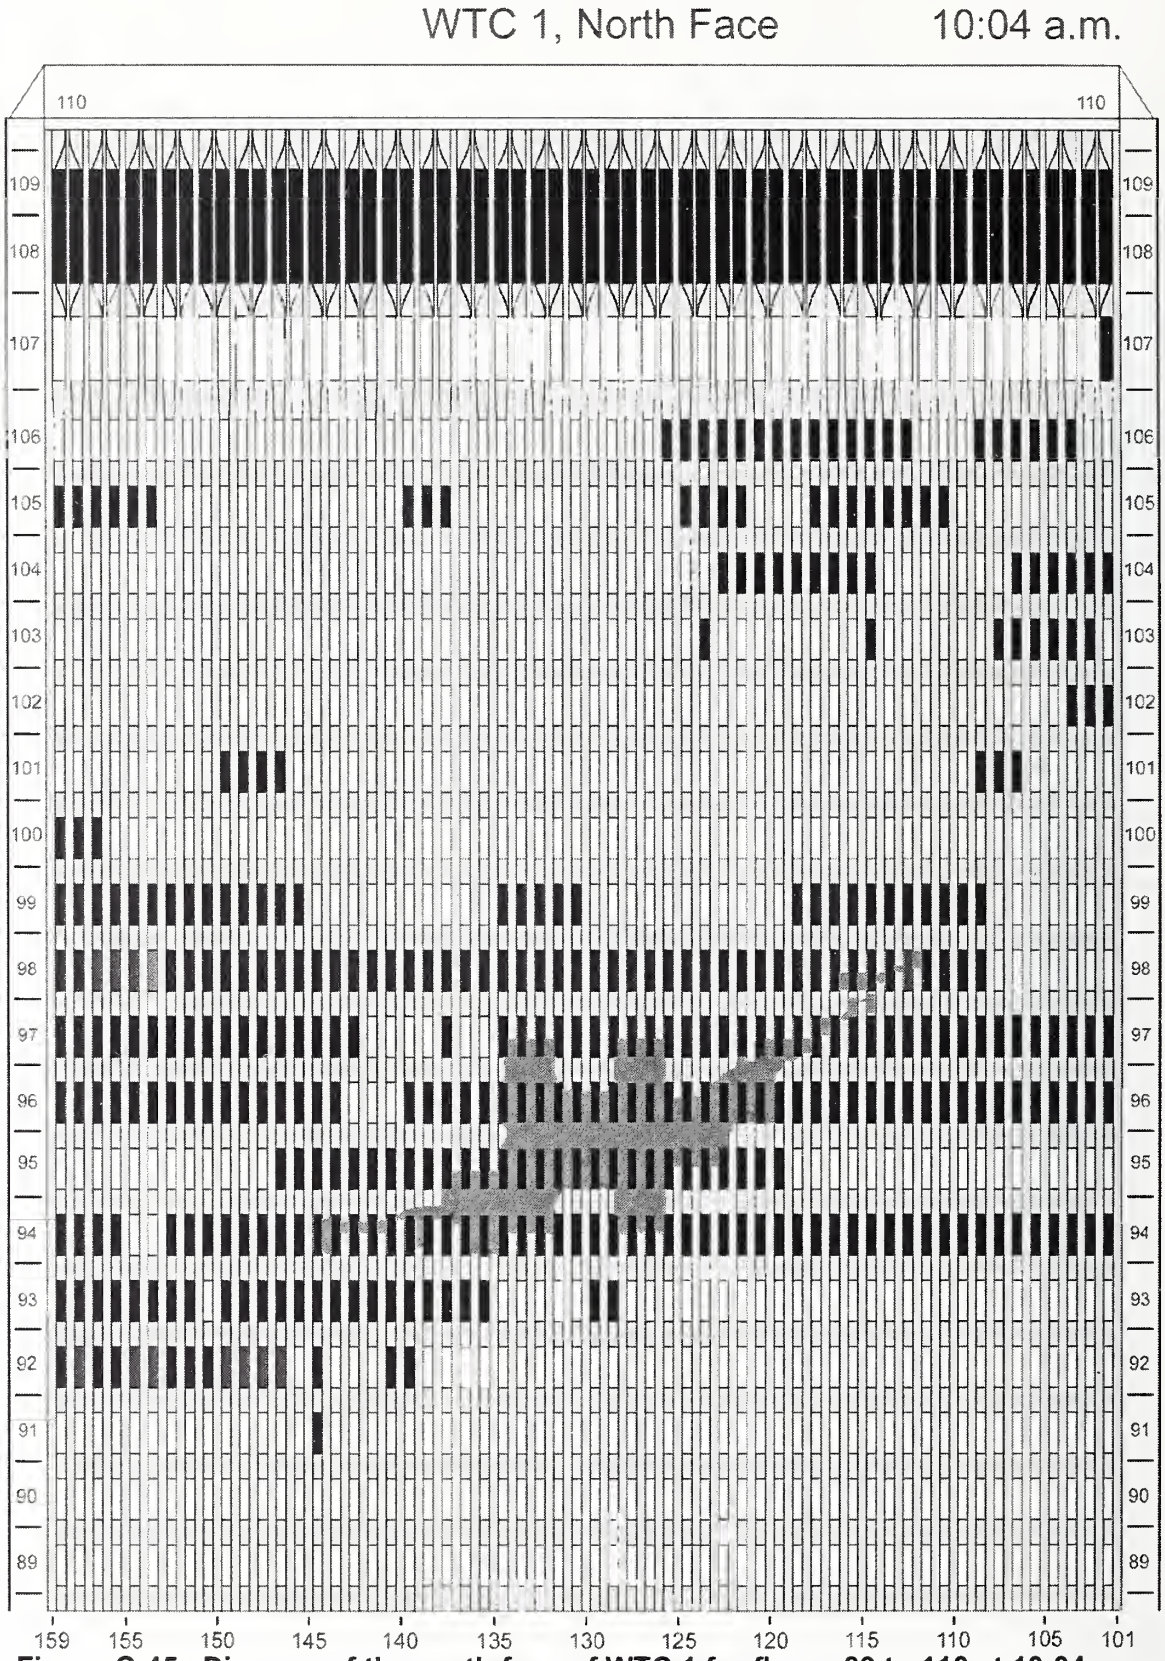
Figure C-45. Diagram of the north face of WTC 1 for floors 89 to 110 at 10:04 a.m. showing the condition of windows and locations of fires.

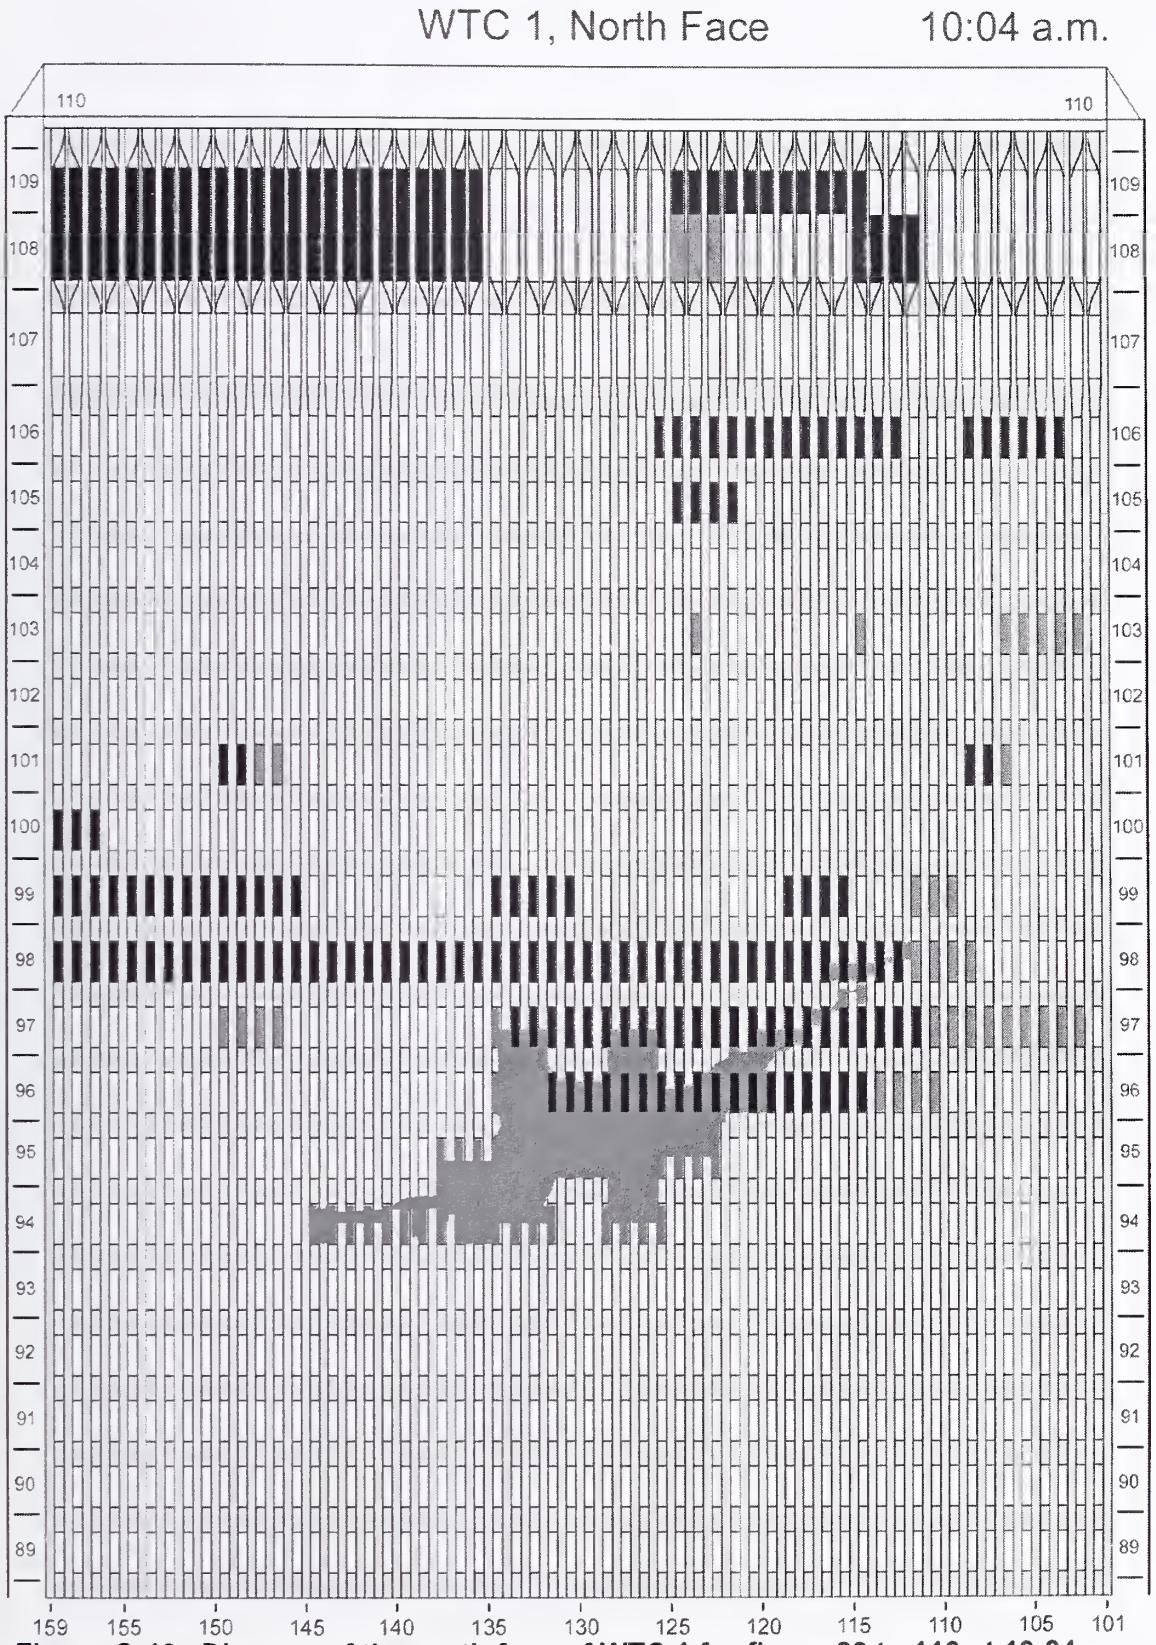
Figure C-46. Diagram of the north face of WTC 1 for floors 89 to 110 at 10:04 a.m. showing windows where smoke was observed and those that were hidden from view.

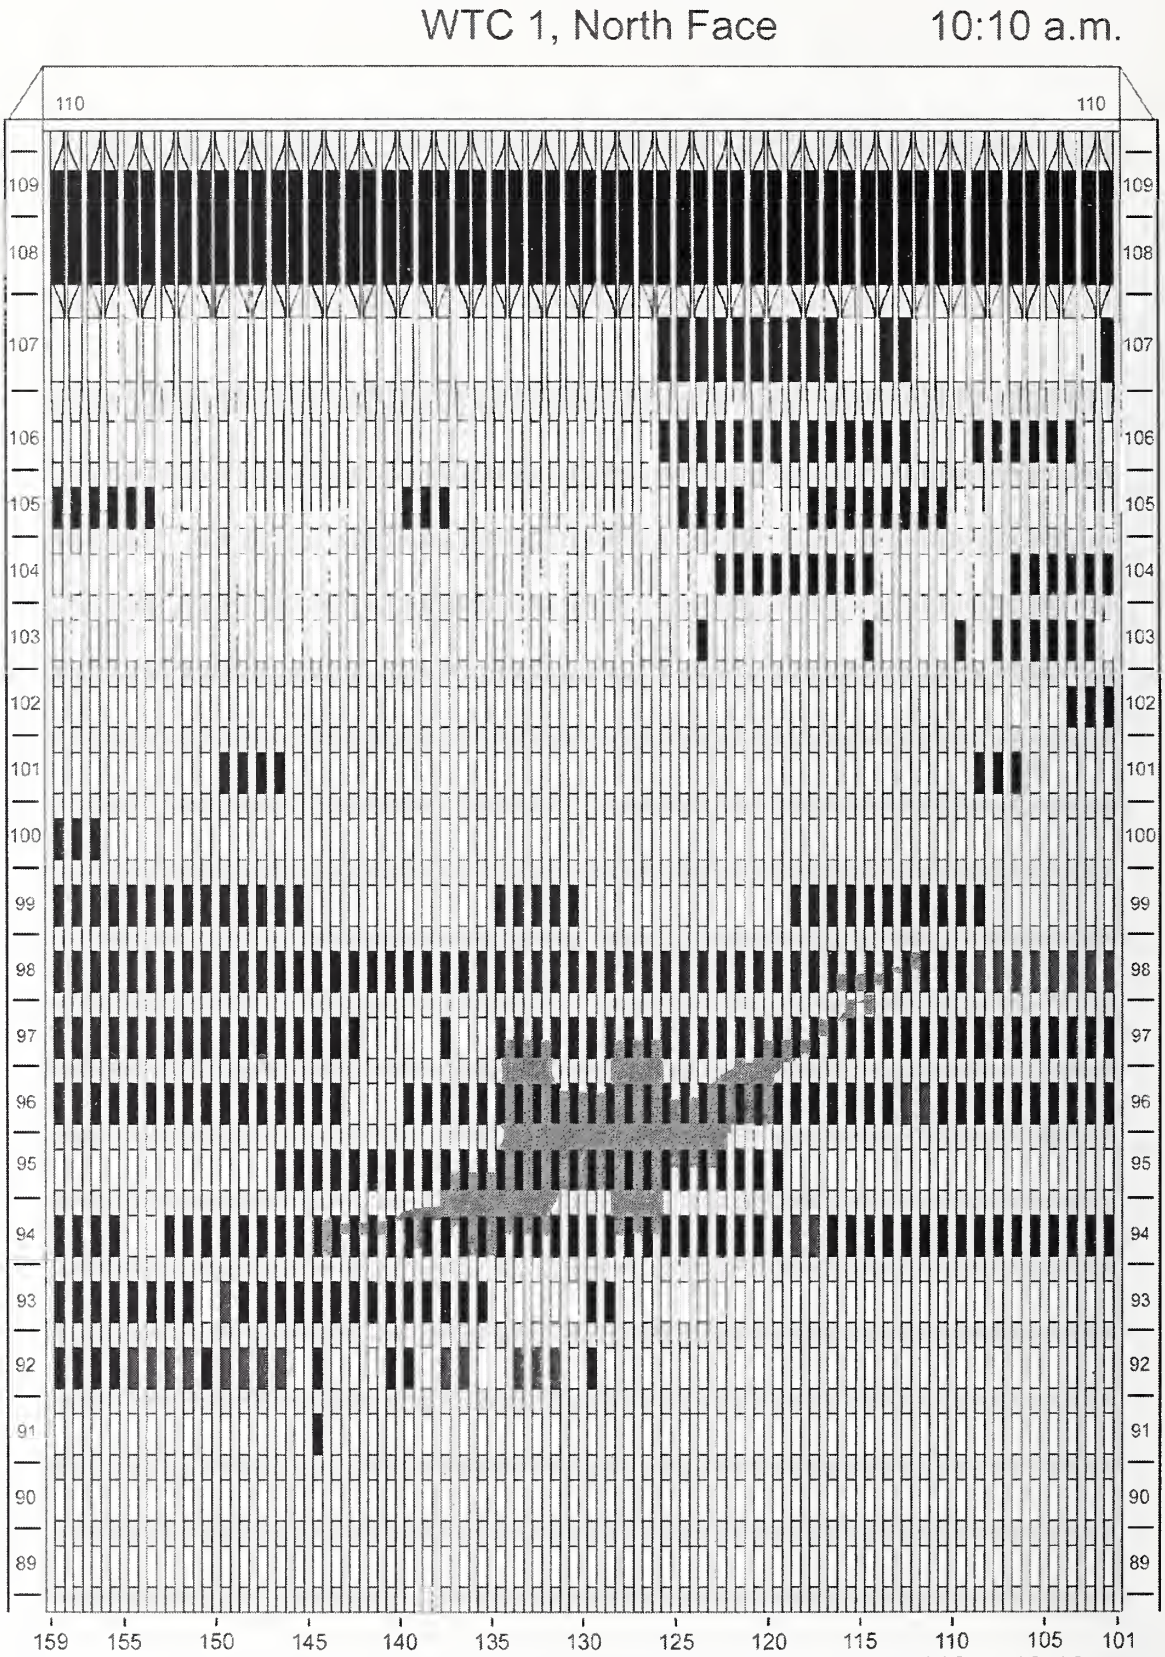
Figure C-47. Diagram of the north face of WTC 1 for floors 89 to 110 at 10:10 a.m. showing the condition of windows and locations of fires.

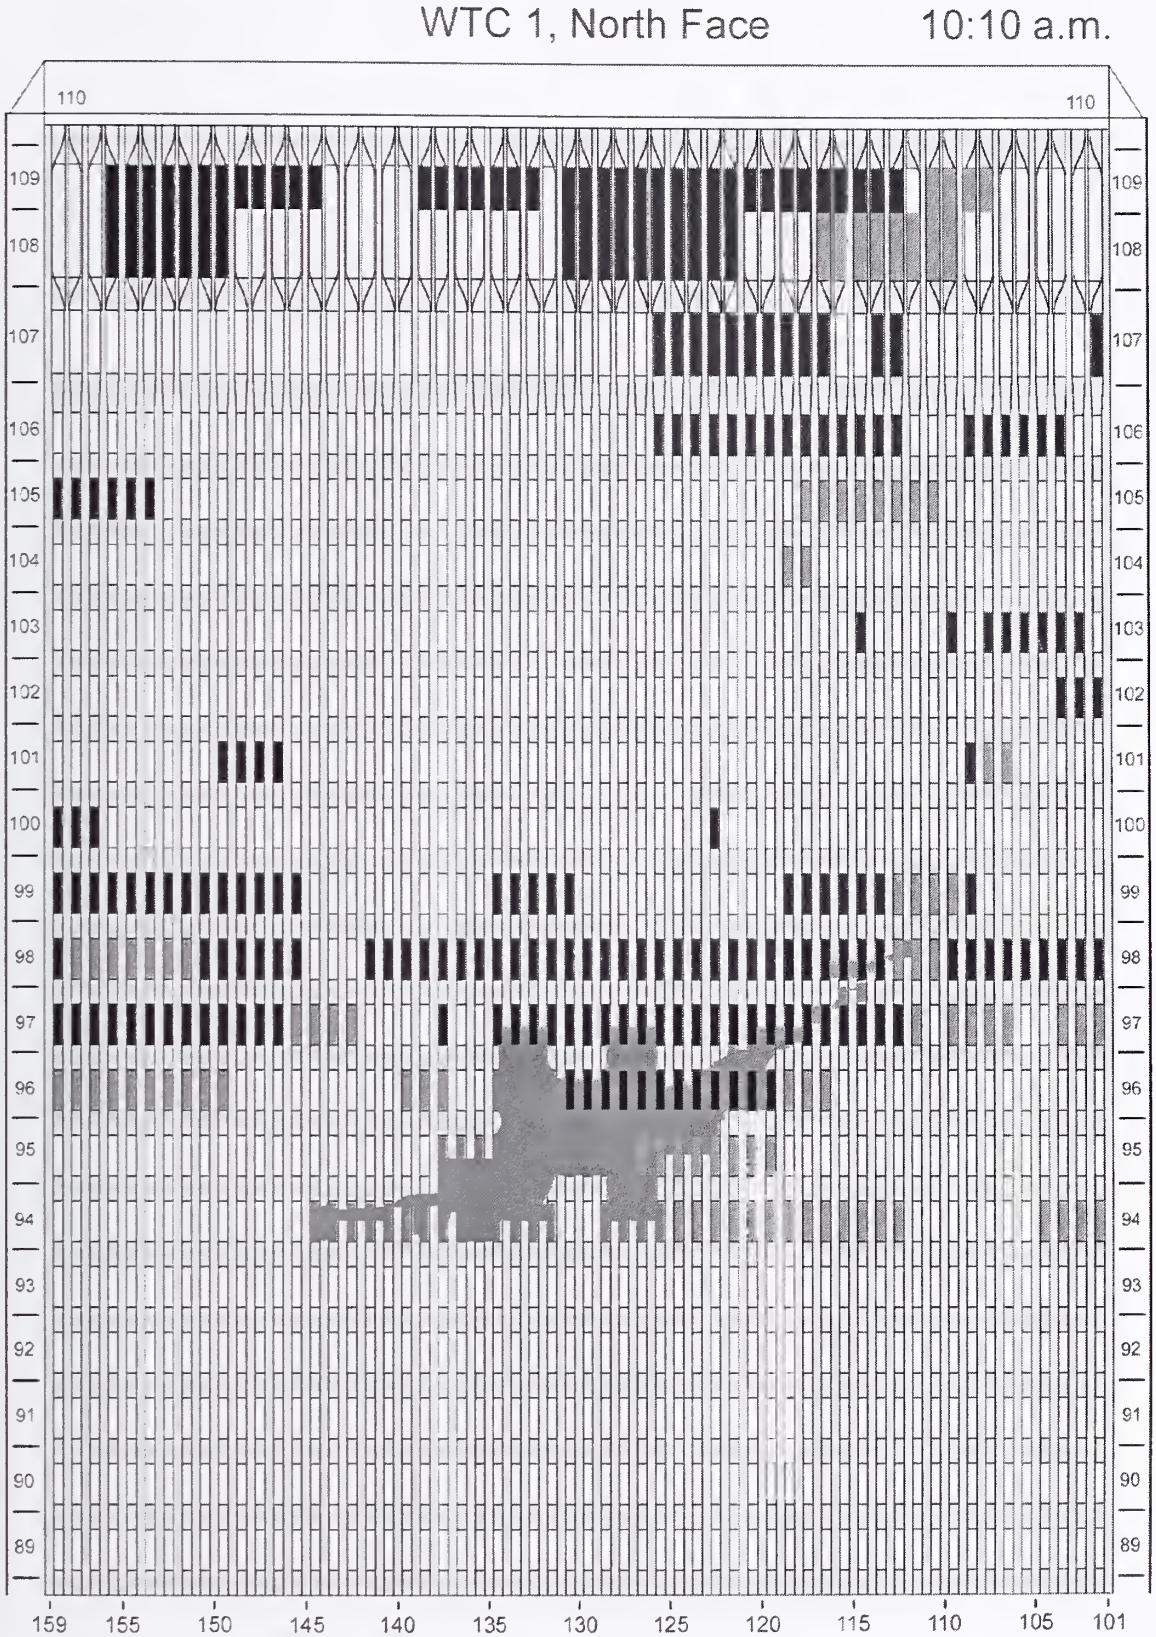
Figure C- 48. Diagram of the north face of WTC 1 for floors 89 to 110 at 10:10 a.m. showing windows where smoke was observed and those that were hidden from view.

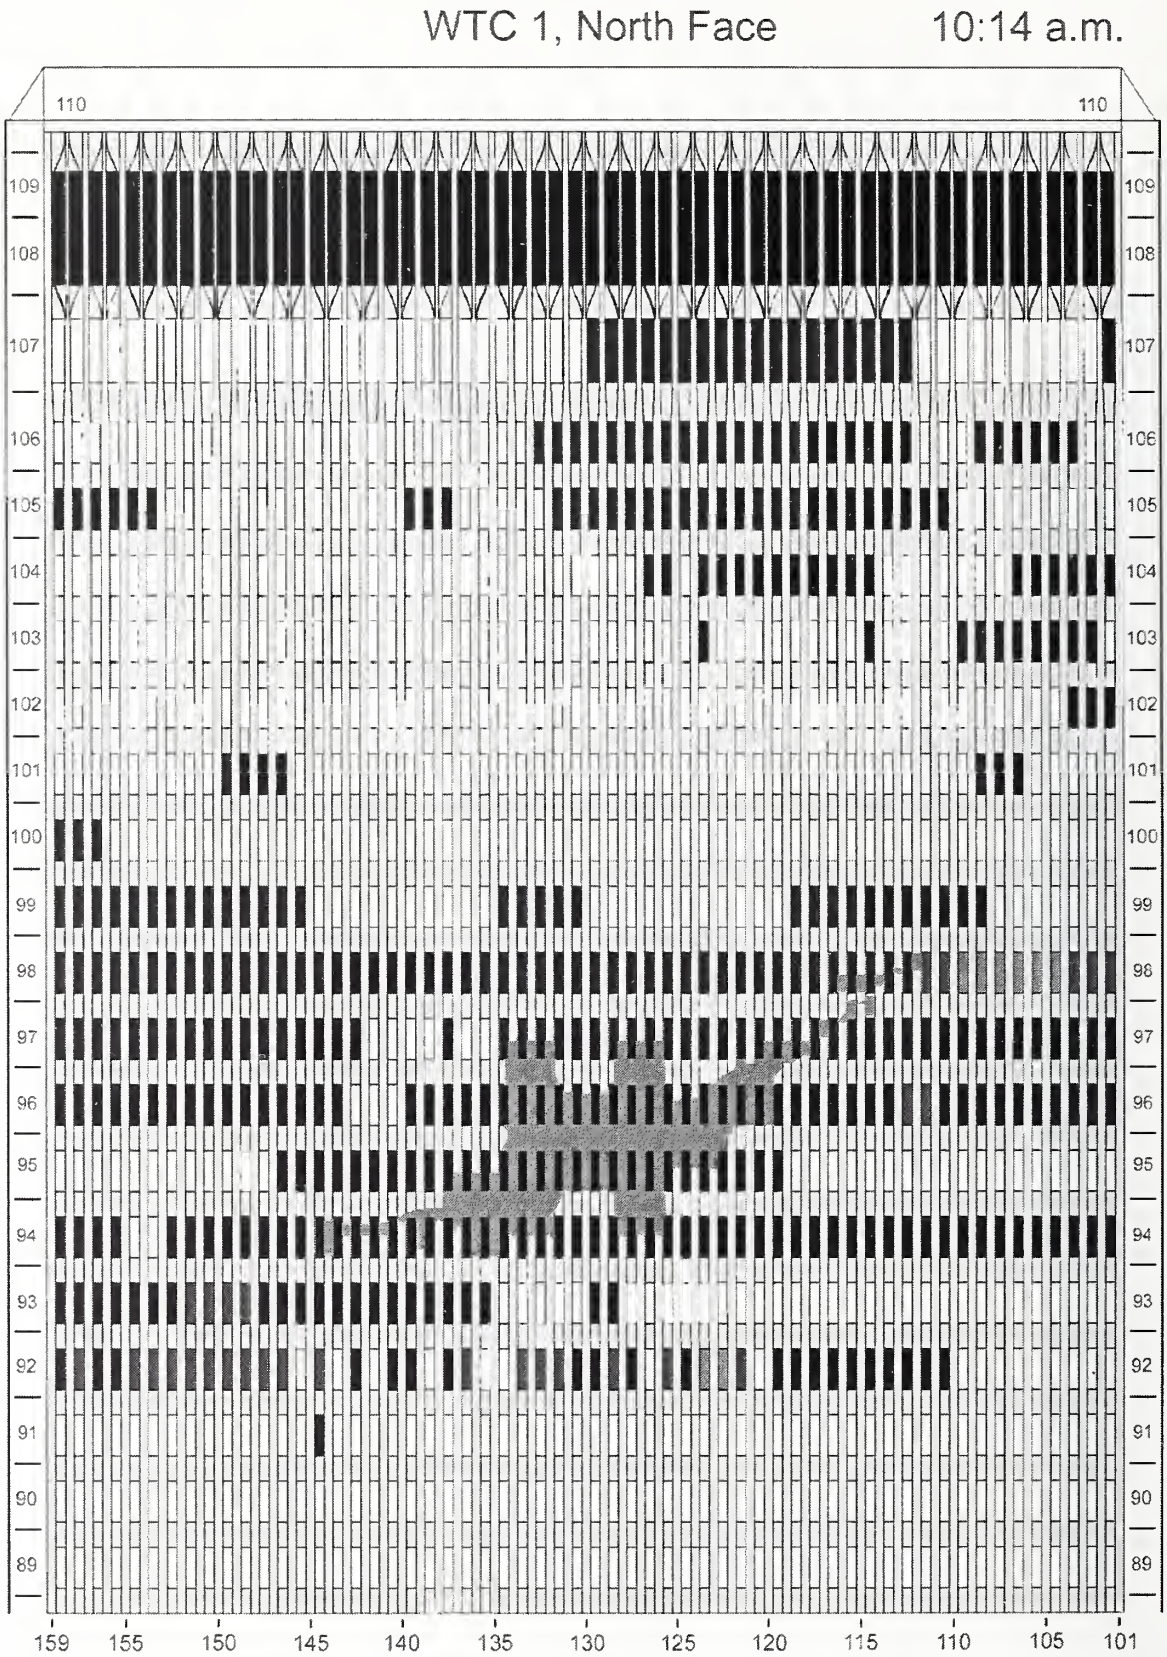
Figure C-49. Diagram of the north face of WTC 1 for floors 89 to 110 at 10:14 a.m. showing the condition of windows and locations of fires.

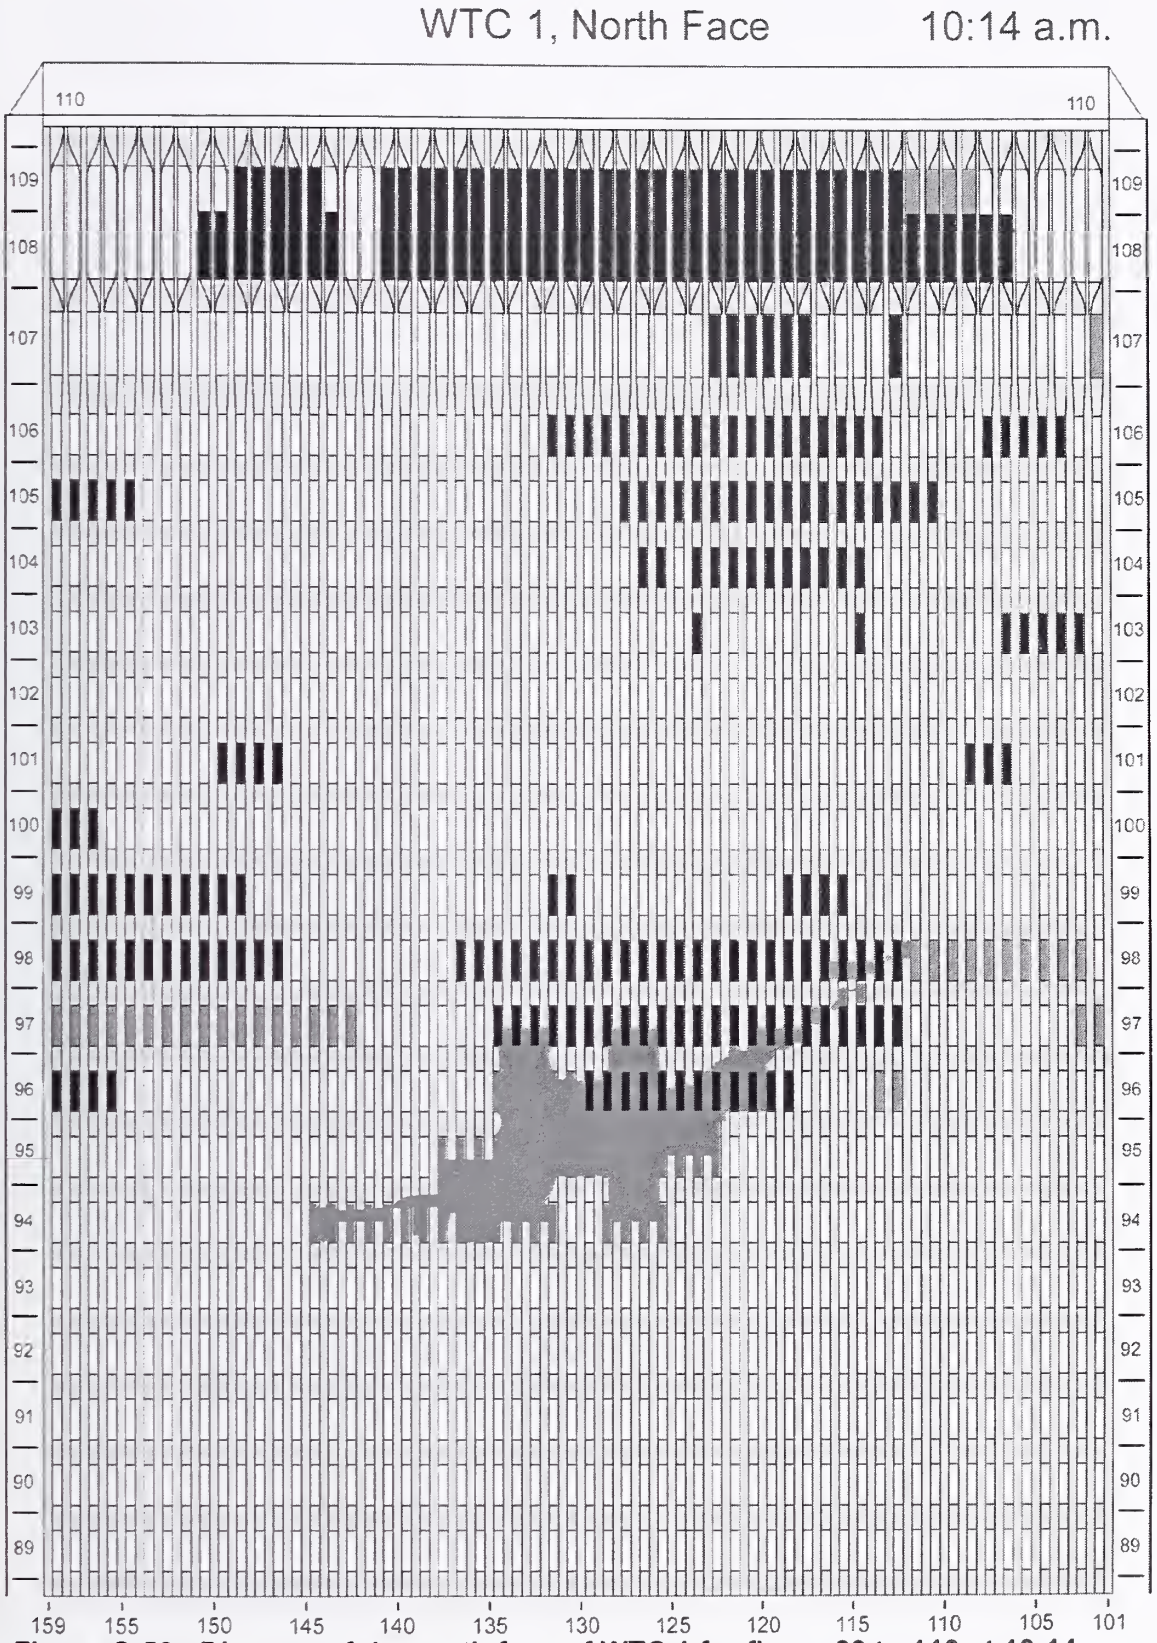
Figure C-50. Diagram of the north face of WTC 1 for floors 89 to 110 at 10:14 a.m. showing windows where smoke was observed and those that were hidden from view.

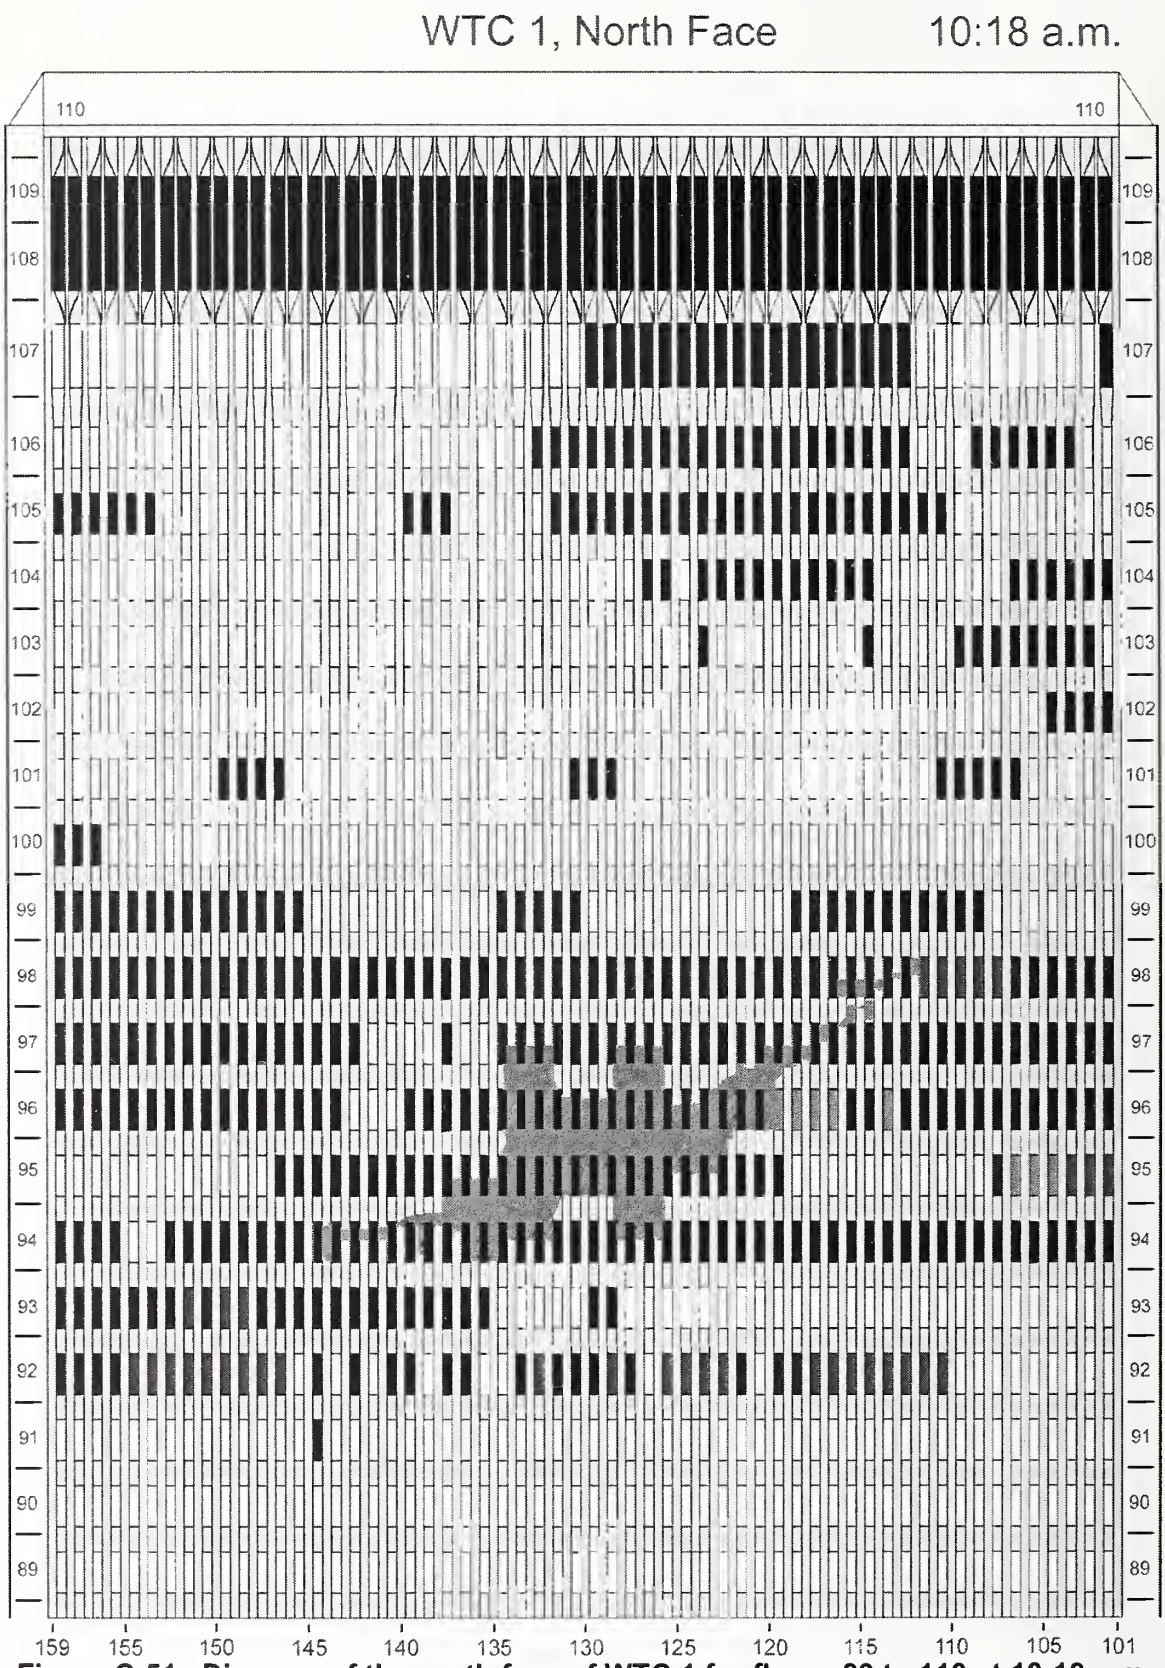
Figure C-51. Diagram of the north face of WTC 1 for floors 89 to 110 at 10:18 a.m. showing the condition of windows and locations of fires.

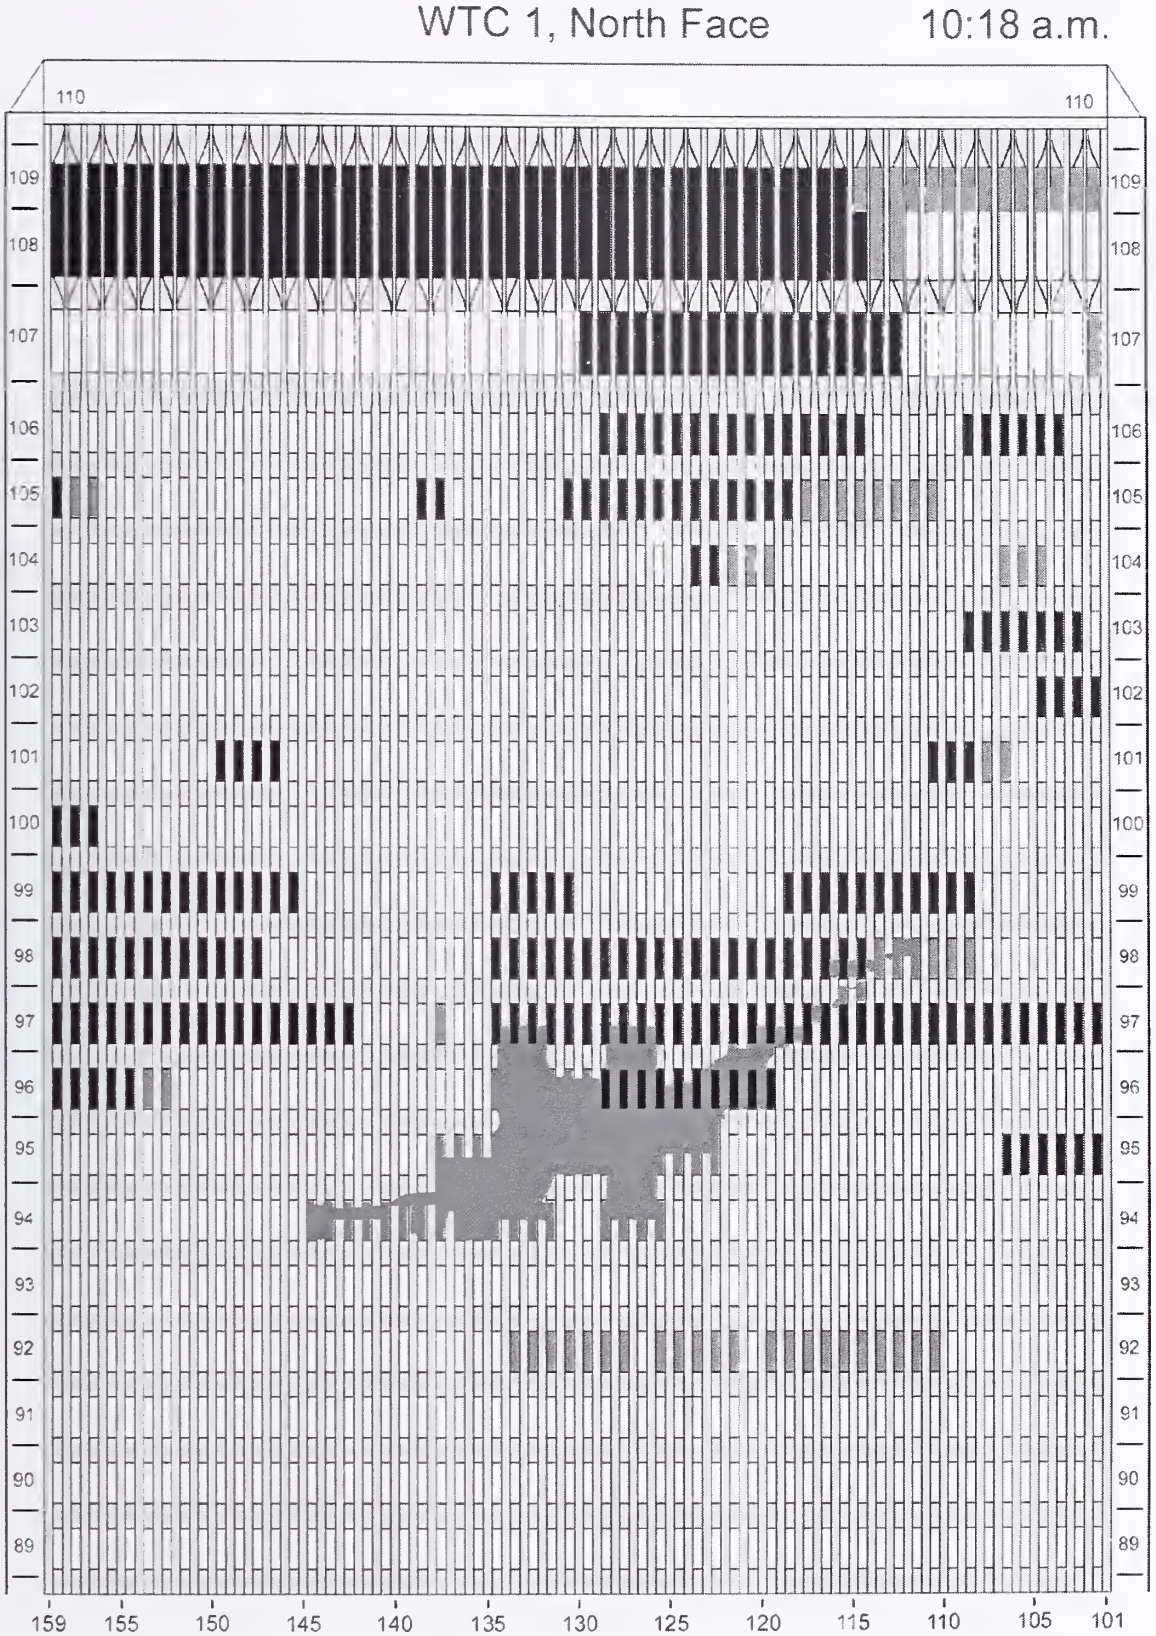
Figure C-52. Diagram of the north face of WTC 1 for floors 89 to 110 at 10:18 a.m. showing windows where smoke was observed and those that were hidden from view.

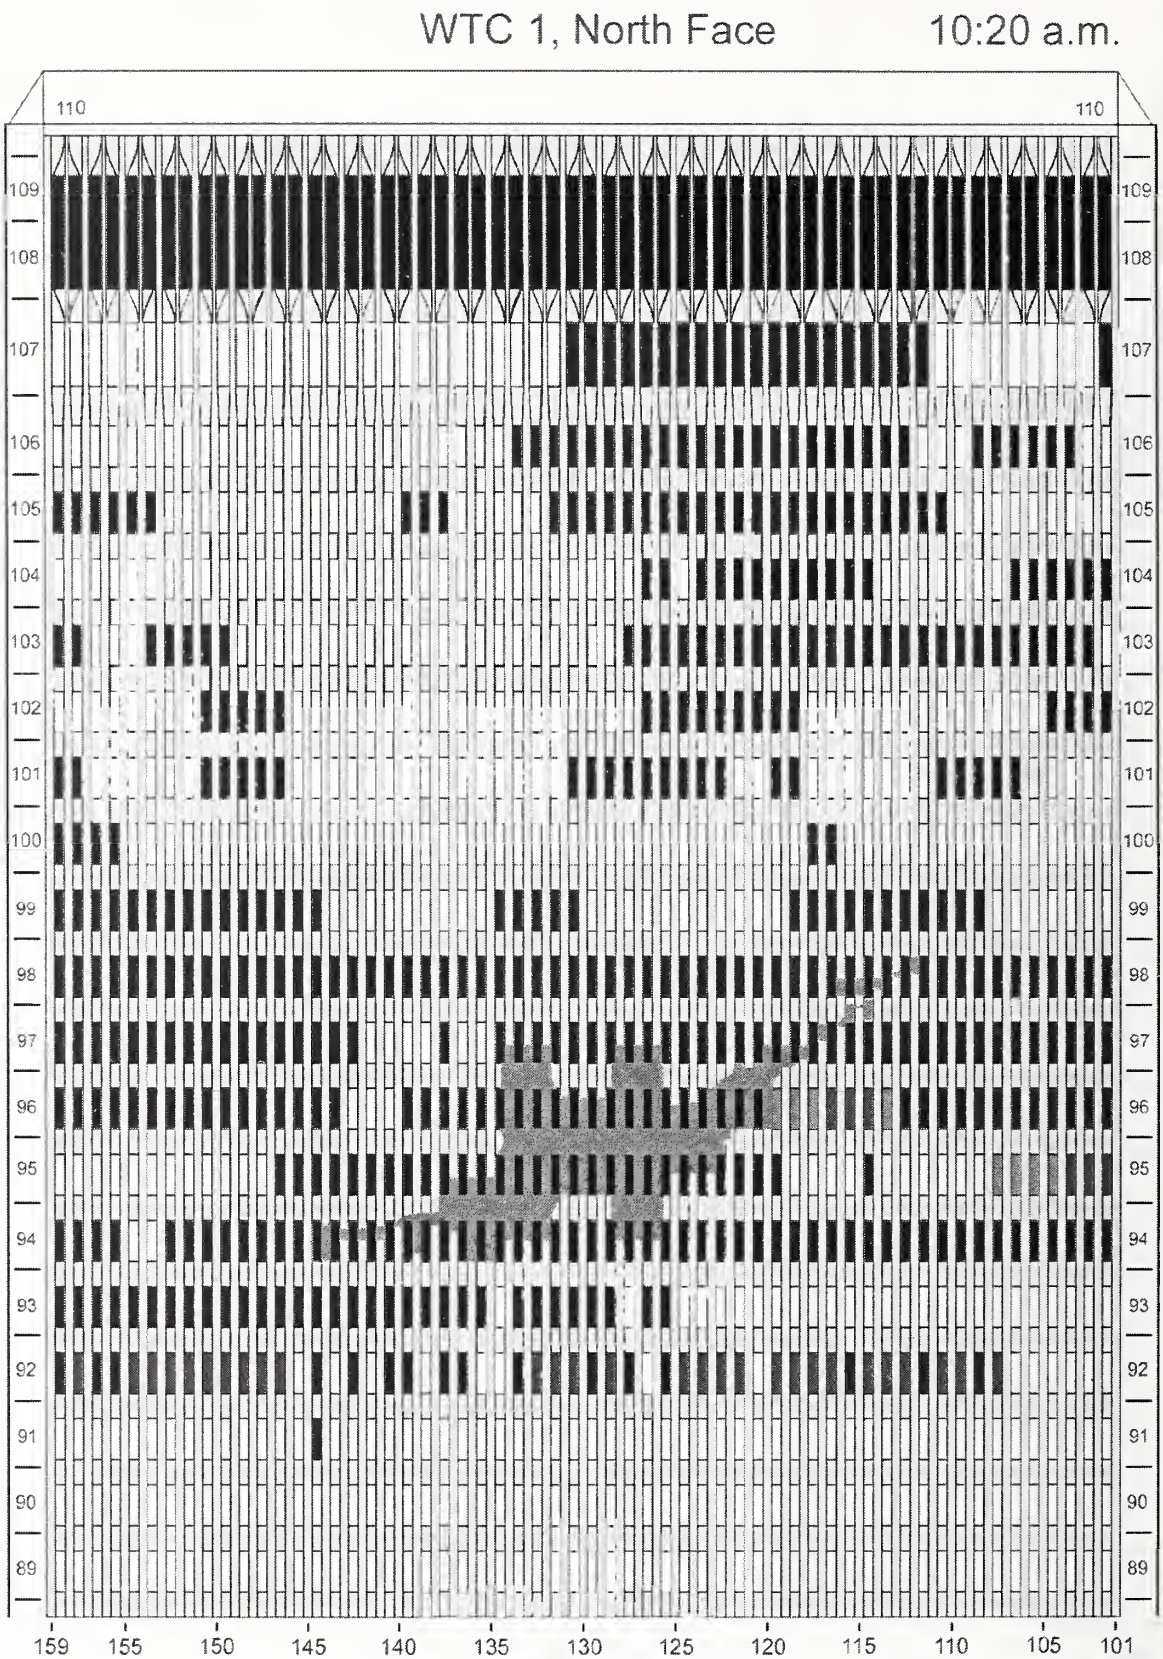
Figure C-53. Diagram of the north face of WTC 1 for floors 89 to 110 at 10:20 a.m. showing the condition of windows and locations of fires.

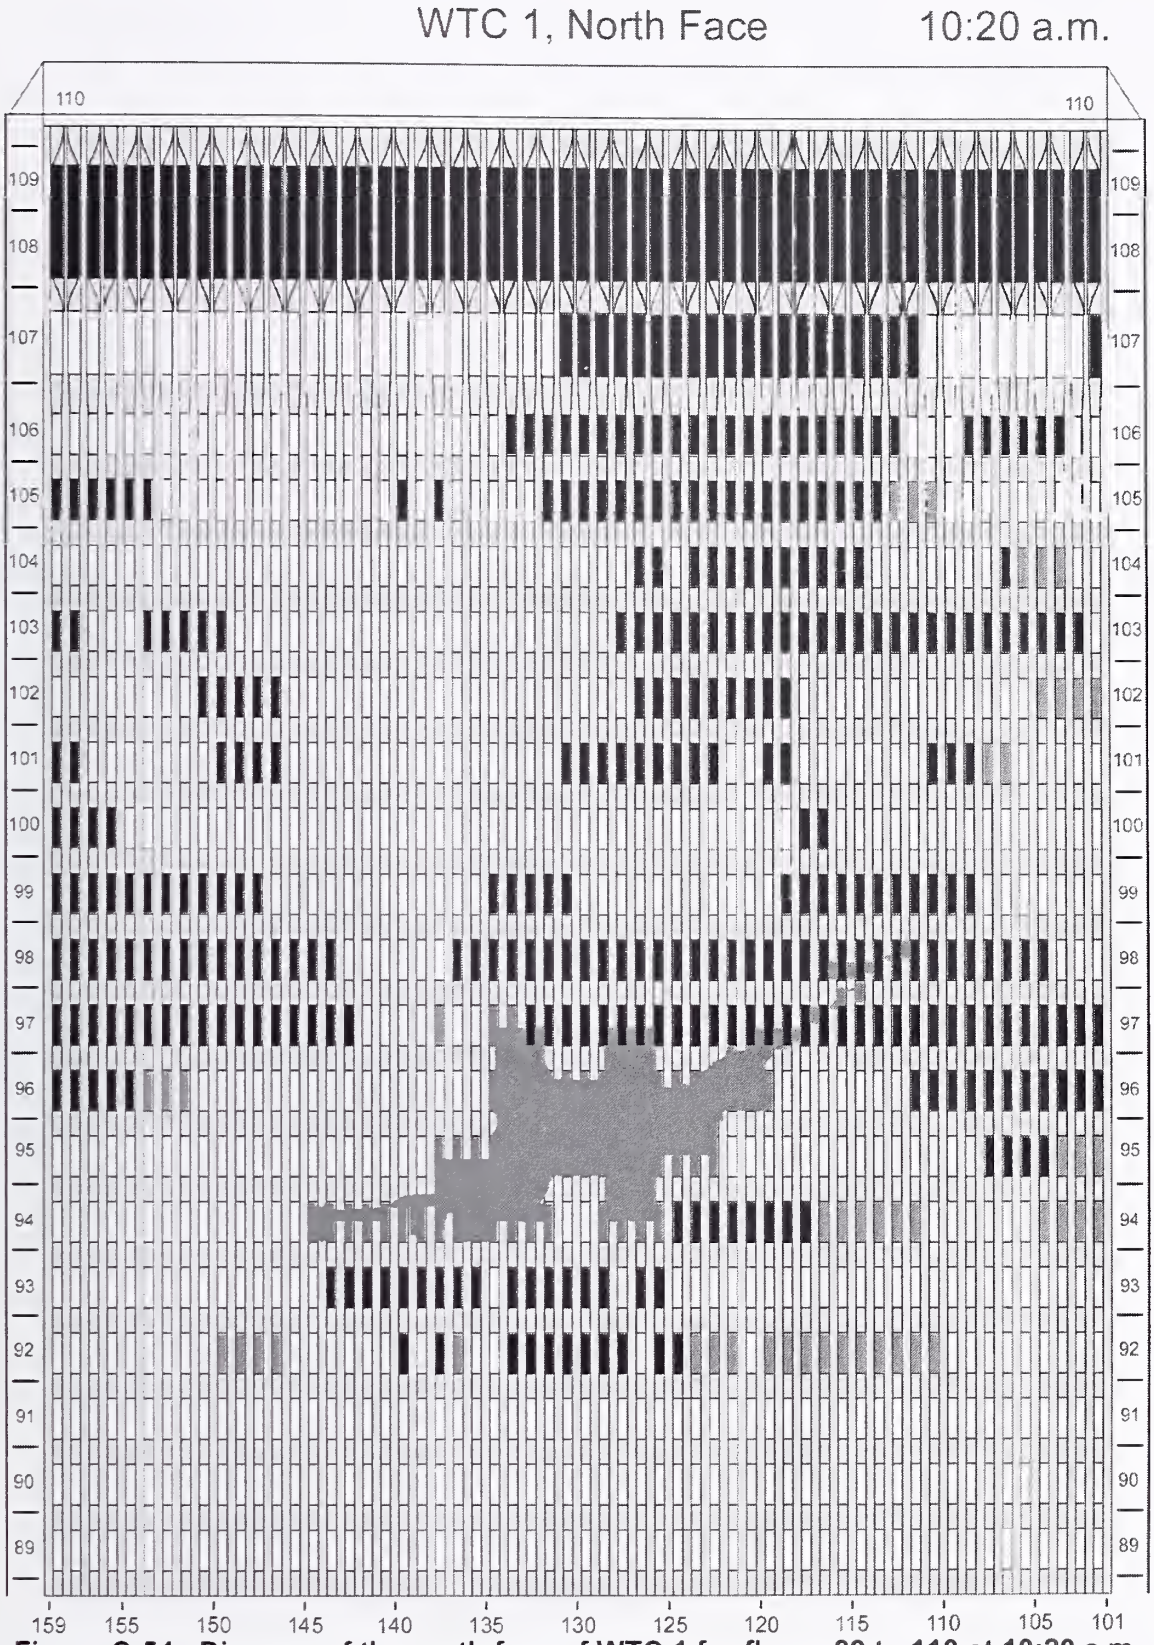
Figure C-54. Diagram of the north face of WTC 1 for floors 89 to 110 at 10:20 a.m. showing windows where smoke was observed and those that were hidden from view.
